AD NO. _____
TECOM PROJECT NO. 8-EI-495-BPF-001
REPORT NO. ATC-8199 (VOLUME II)
USAISR INSTITUTE REPORT LEAP 99-2

VOLUME II
FINAL REPORT
OF THE
LOWER EXTREMITY ASSESSMENT PROGRAM (LEAP 99-2)

U.S. ARMY INSTITUTE OF SURGICAL RESEARCH
EXTREMITY TRAUMA STUDY BRANCH
FORT SAM HOUSTON, TX 78234-6315

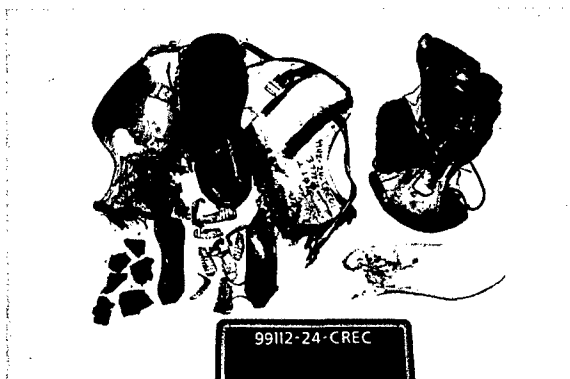
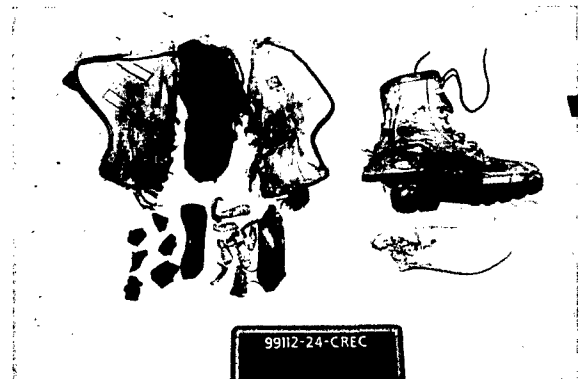
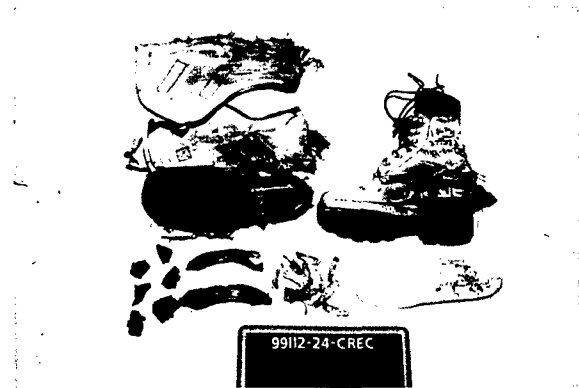
The rear 4 inches of the overboot sole has been completely destroyed by the blast. The blast deflector, attenuator, and attenuator plate have all been completely separated from the overboot. The blast deflector has been badly flattened and folded, resulting in a 3-inch split in the metal along the rear two-thirds of its mid-line. The blast deflector has also been bent upward approximately 1 inch in its center. The attenuator has been separated from the attenuator plate and shredded into several small fragments, which have been completely compressed. The attenuator plate is bent upward approximately 1 inch in its center. The Kevlar insole remains attached to the overboot, and appears to be undamaged. Its canvas cover remains attached, but has sustained several small tears over the mid-point of the heel. Both the medial and lateral portions of the Kevlar upper have been completely separated from the overboot, and have been separated down the Achilles seam. The medial portion of the Kevlar upper appears to be undamaged, while the lateral portion has a 3 1/2-inch vertical tear with extensive shredding in the Kevlar material over the lateral portion of the heel 3 inches forward of the Achilles seam.

The sole of the Singapore boot has sustained a 2 1/2-inch longitudinal tear over the mid-heel. The sole has been separated from the leather upper and insole of the boot from the heel to mid-foot. The Kevlar insole appears to be undamaged. There is a 6-inch vertical tear completely through the leather upper and Kevlar lining along the Achilles tendon. The Kevlar lining over the insole appears to be intact. The heel portion of the cushion insole has been badly shredded. The white paint applied pretest to the boot has flaked off along wrinkle lines indicating compression of the leather upper.

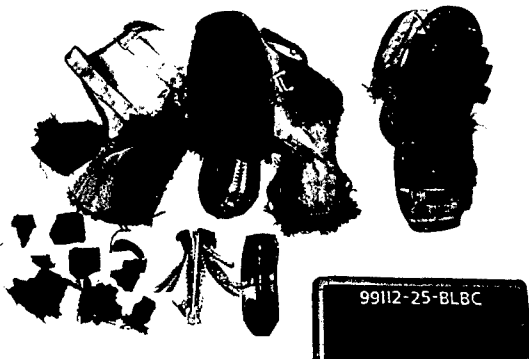
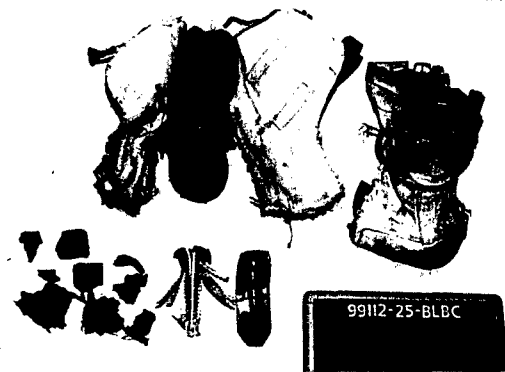
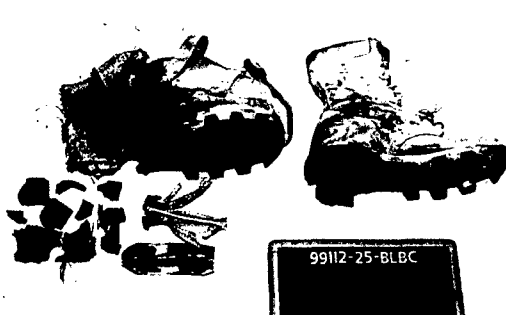
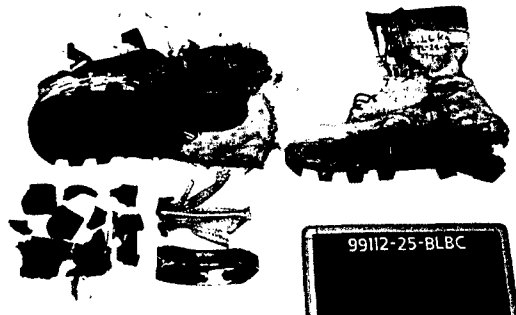
PMN mine with blast boot/overboot combination

The rear 4 inches of the heel portion of the overboot has been destroyed and recovered in several large pieces. The blast deflector and attenuator have been separated from the overboot. The blast deflector has been moderately flattened, and bent upward approximately one-half inch in its center. The attenuator has been compressed and shredded down its entire length. The attenuator plate remains affixed to the underside of the Kevlar insole. The Kevlar insole remains attached to the overboot and appears to be intact and undamaged. Both sides of the Kevlar upper have been separated from the sole of the overboot from the heel to mid-foot. Both halves of the Kevlar upper have been completely separated at the Achilles seam, but there appears to be no damage to the Kevlar material itself. The blast deflector, attenuator, and attenuator plate of the blast boot have been flattened/compressed in the center causing the rear portion to tear through the sole of the blast boot in the heel area between the lugs of the sole. The blast deflector, attenuator, and attenuator plate remain attached to the boot. There appears to be no damage to the Kevlar insole. There is a 3-inch vertical tear in the leather upper on the lateral side of the heel area, and a 1/2-inch tear in the heel cap. There is a 2-inch lateral tear in the cushion insole. There are three small tears in the leather upper over the medial malleolus.

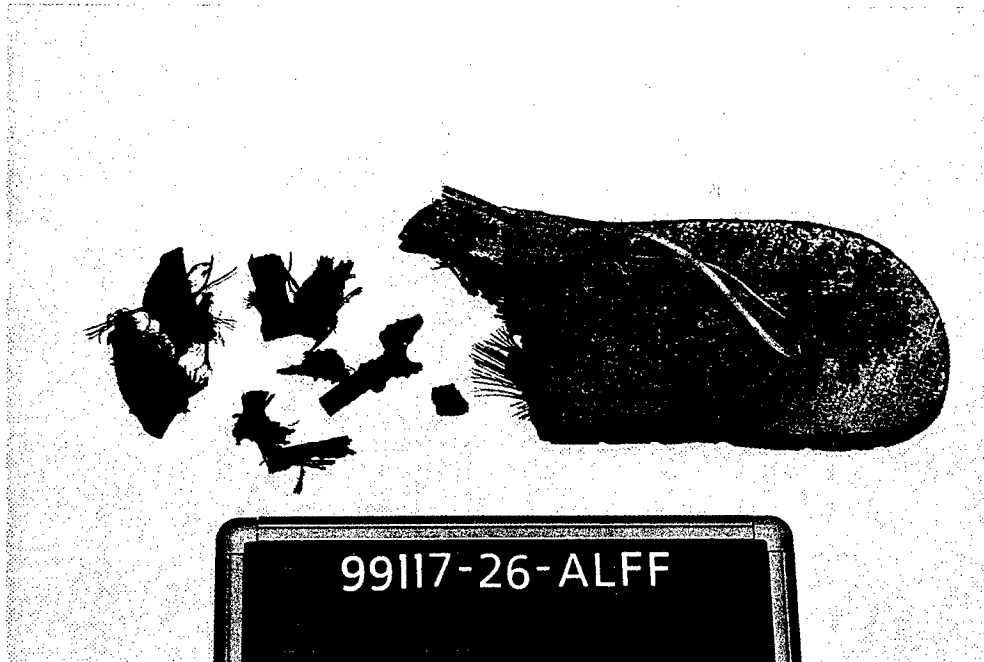
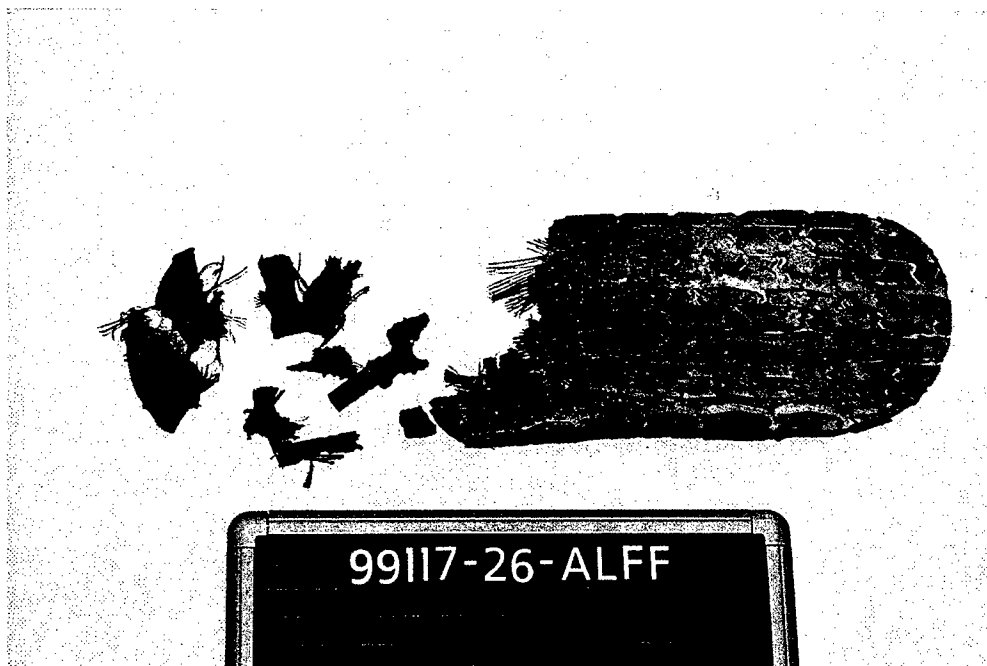
Shot # 26

ID # 99117-26-ALFF

M14 Mine with the improvised footwear/tire sandal

The rear one-third of the sandal has been completely destroyed and recovered in several small pieces.

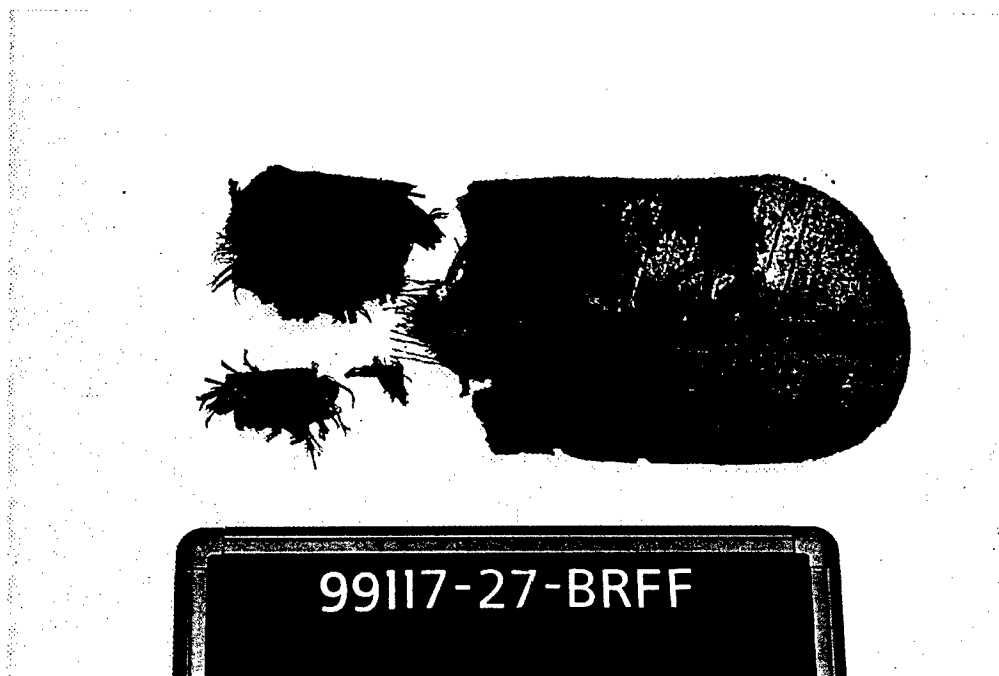
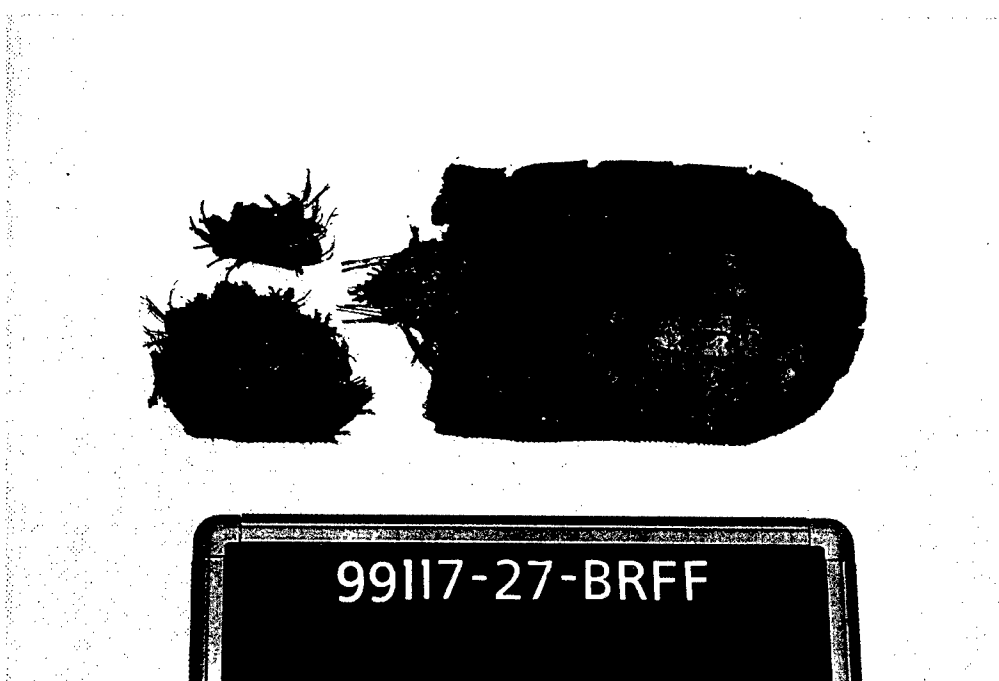
Shot # 27

ID # 99117-27-BRFF

PMN Mine with improvised footwear/tire sandal

The rear one-third of the sandal has been completely destroyed with one large fragment and two smaller pieces being recovered.

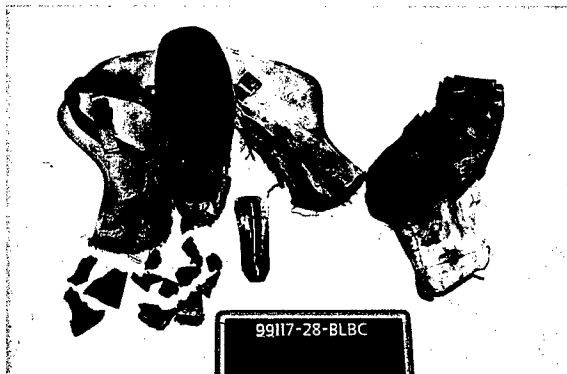
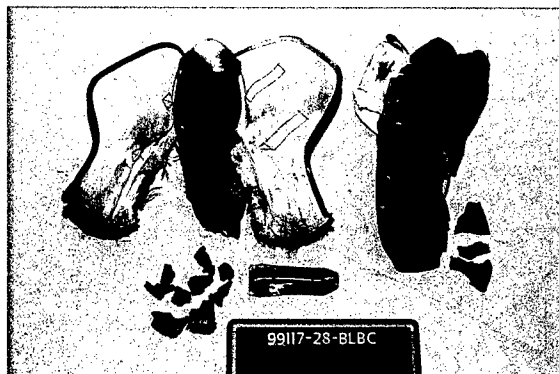
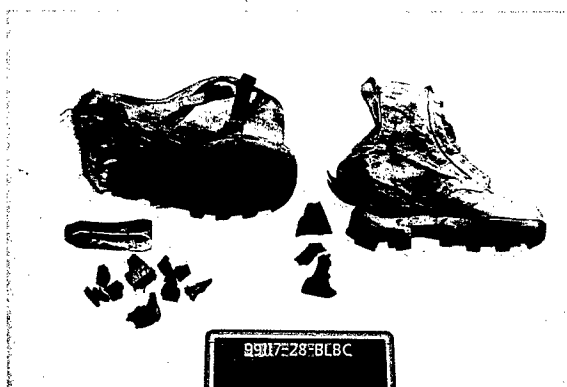
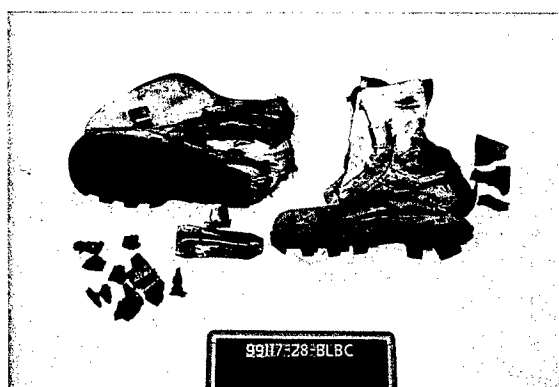
The sole of the blast boot has a 3-inch diagonal tear across mid-heel. This tear is split open approximately 1-inch exposing the rear portion of the blast deflector. The blast deflector, attenuator, and attenuator plate remain attached to the blast boot. There appears to have been significant flattening/compression of the blast deflector/attenuator within the sole of the blast boot. The Kevlar insole remains attached to the blast boot with the only damage being a piece of bone which has penetrated the top layers on the medial side of the heel. The leather upper has been completely separated from the sole from the rear of the heel to the arch on the medial side. The upper has been shredded by a 6-inch vertical tear extending from the sole upward on the lateral side of the heel. The cushion insole has a 2-inch longitudinal tear at mid-heel and is missing a 2-inch x 1-inch section from the medial side of the heel.

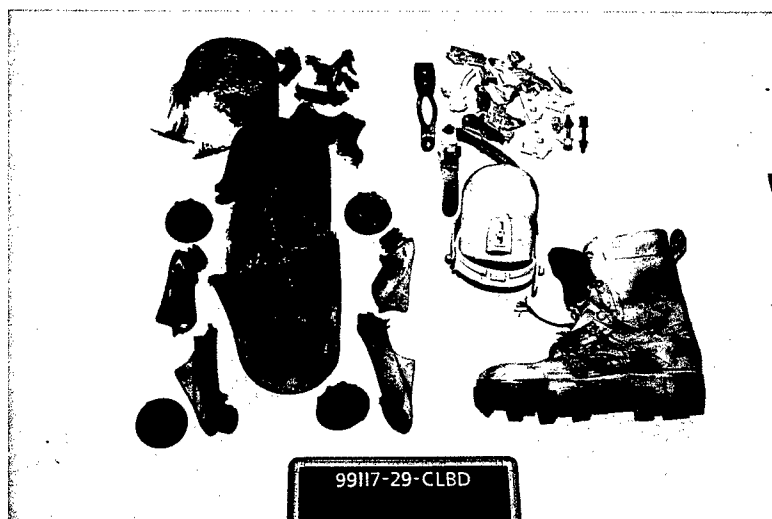
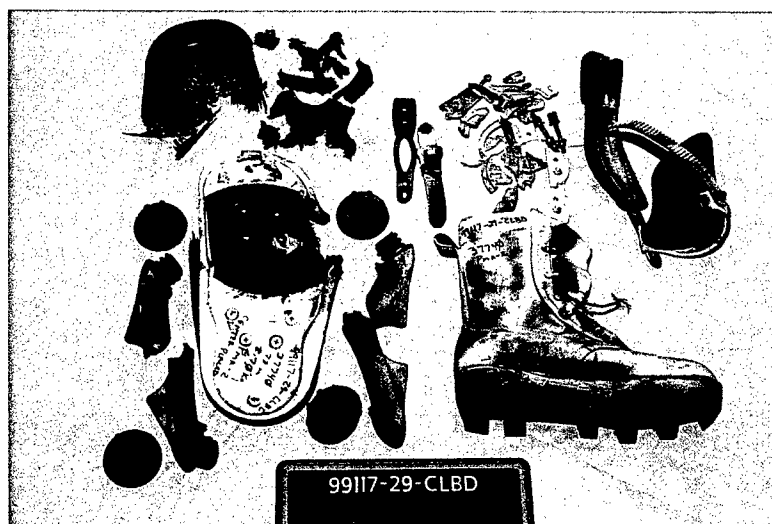
There is a ½-inch tear in the leather upper of the blast boot, below the third eyelet on the lateral side. There appears to be a slight concavity of the sole of the blast boot at mid-heel, indicating possible internal compression of the deflector/attenuator.

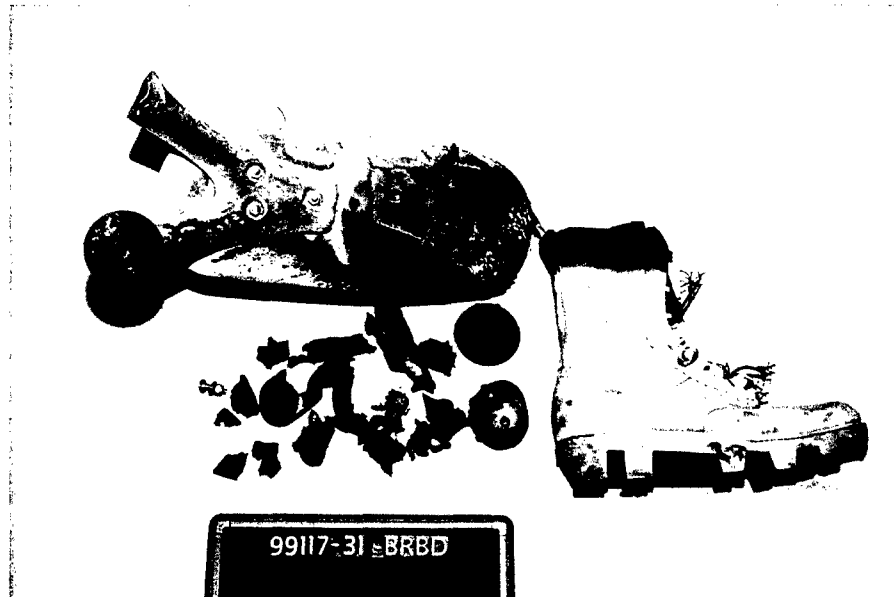
Shot # 31

Both of the overboot's front legs were removed by the blast, and recovered in several small pieces. The upper portion of the legs, which remain attached the body of the boot, were badly mangled. A 3-inch x 4-inch section has been blown out of the underside of the body of the boot. The toe area of the insole has been slightly bent upward. The bindings and binding attachment plate appear to be intact and undamaged. The rubber foot of the right rear leg has been removed by the blast.

The blast boot is completely intact and appears to be undamaged.
